Station Notes February 18, 2004

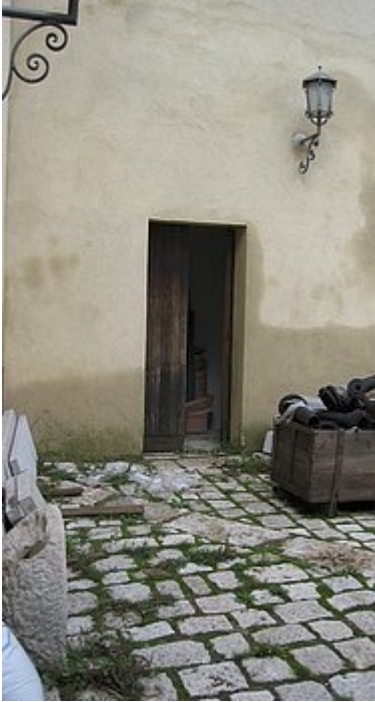
SACO - Sant'Andrea di Conza

Below municipio building in back portion of storage area. Access door on left side of municipio building courtyard.

* Need GPS serial number.

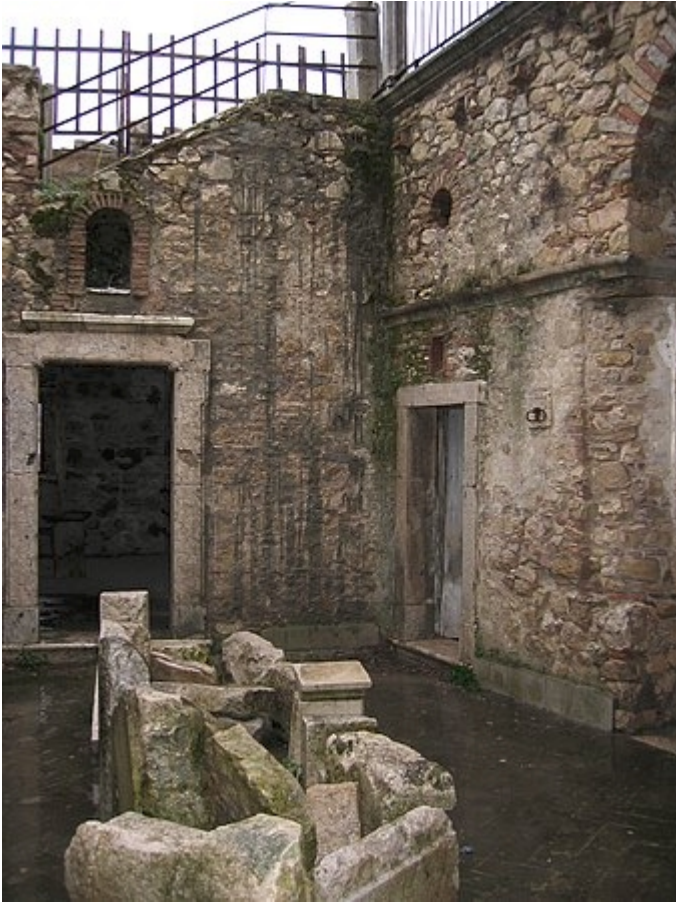
GROM - Grottaminarda

Below INGV building in Grottaminarda. Access to outside through the conference room and down to the small wooden door.

* Need GPS serial number, but will have to undo the stick it is mounted on to read it.

2004:019 - Added insulation to sensor cover.

2004:019 - Serviced.

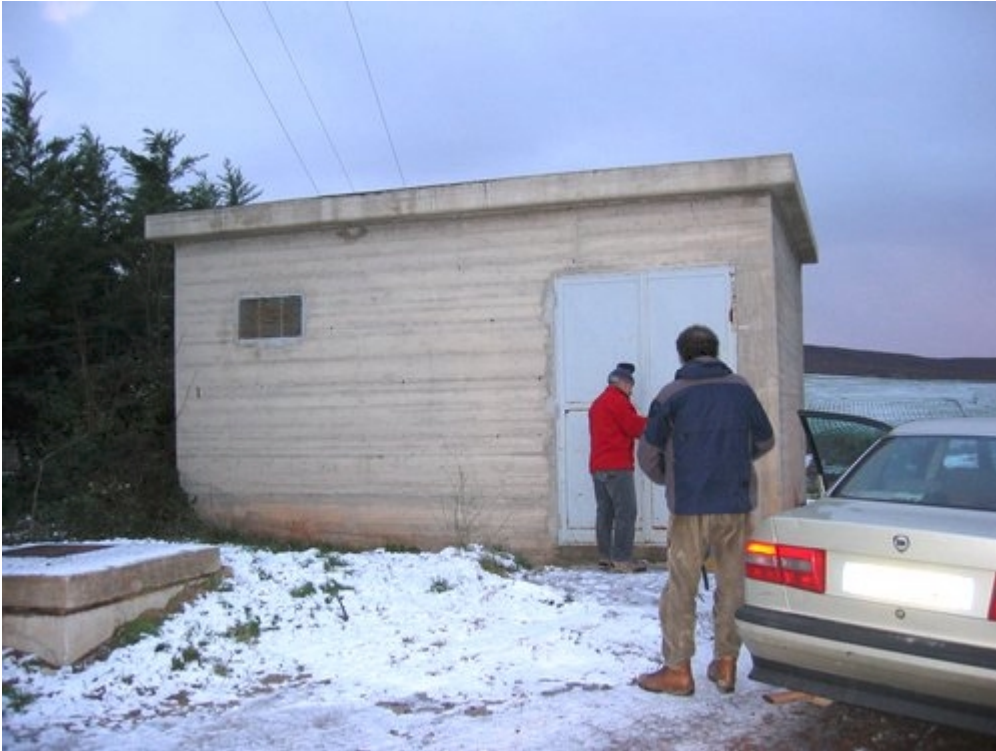
SX17 - Pietragalla

In concrete building near grove of trees under power line.

* Change sample rate to 100sps on next visit.

* Need sensor and GPS serial numbers, though GPS number may be too difficult to bother.

2004:021 - Serviced station. Noted standing water around sensor and the lack of insulation between flower pot and sensor. Still need to change sample rate from 50 sps to 100 sps.

2004:027 - Serviced station. Retrieved one data flash card. Installed insulated box. Attempted to get GPS serial number, but couldn't get on the roof! The GPS hadn't locked in over 3 hours, so take note on next service run.

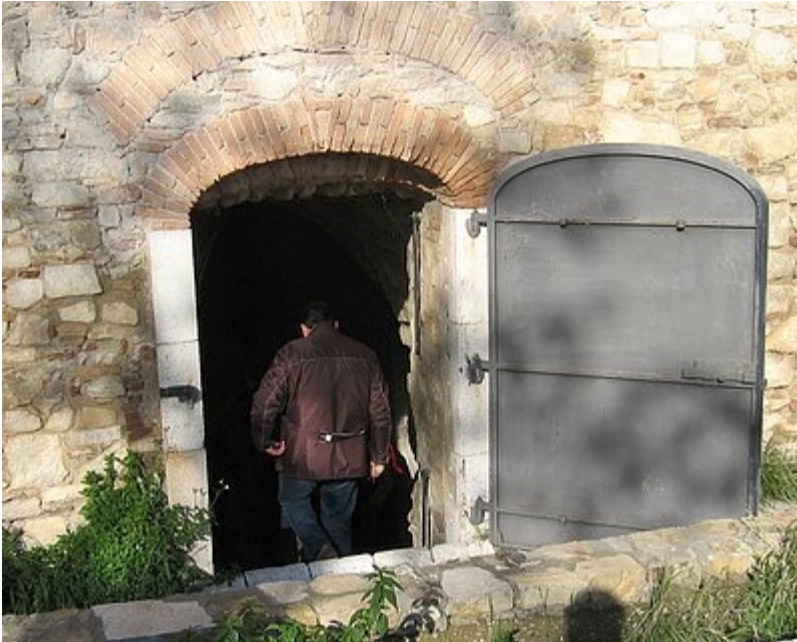
VENO - Venosa

Below municipio building. Access door in back.

* Needs sensor cover with insulation.

2004:021 - Serviced station. Still needs insulation and key copy to get into wine cellar.

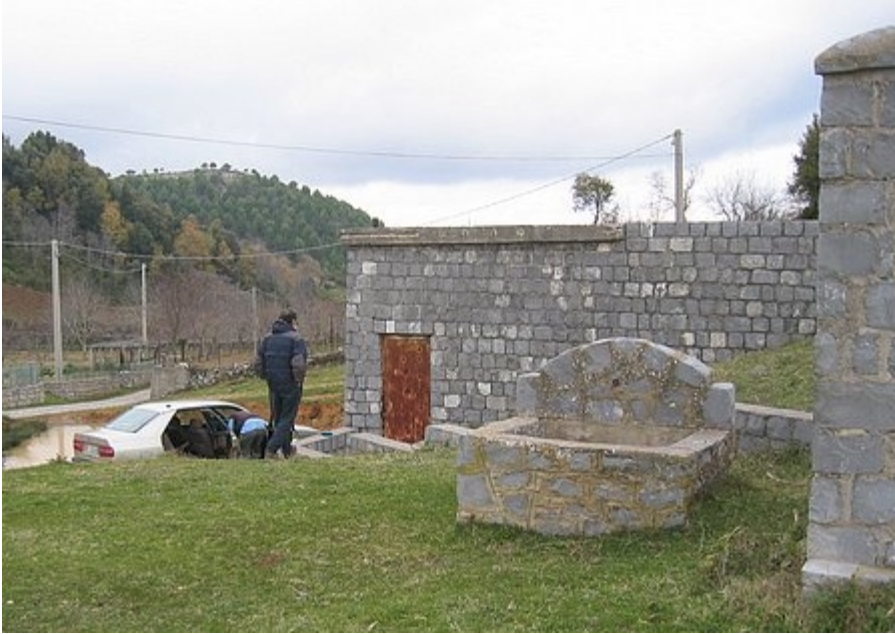
SGIO - San Giovanni a Piro

In unused public toilet building near public park/scenic overlook area.

2004:003 - Sample rate changed 50sps to 100sps.

2004:016 - Serviced station. Replaced second battery with power supply.

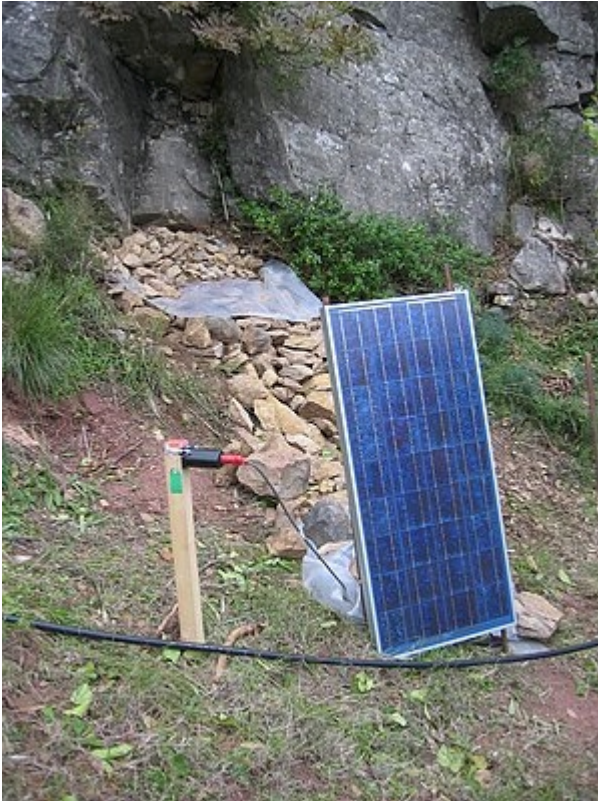
CAVE - Capaccio Vécchio

In grove beyond owners house. Must park at the house and walk.
No special servicing requirements.

* Station may need to be moved to more solid ground.

2004:024 - Stopped acquisition, noting that the GPS hadn't locked for 25 minutes and was still searching for satellites. Removed sensor from hole, expanded and deepened hole, and found that there is no solid bedrock yet exposed to fasten onto at the bottom of the hole. Poured large cement pedestal, attached to solid rock wall, but cement did not dry after 2 hours. Need to return to finish installation, add foam insulation, and check on GPS lock (which still had not occurred before departure).

2004:026 - Completed installation, including adding foam insulation. GPS locked ~25 minutes before, so it seems to be working. Difficulties with centering led to locking and unlocking the station a second time, with the final result of channel #1 reporting a +1.1 centering voltage. This remained true even after further attempts at centering. Residence owner invited the team in for a fantastic lunch, including homemade bread, sausage, wine, and olives. Incredible hospitality makes this an excellent site for service calls!

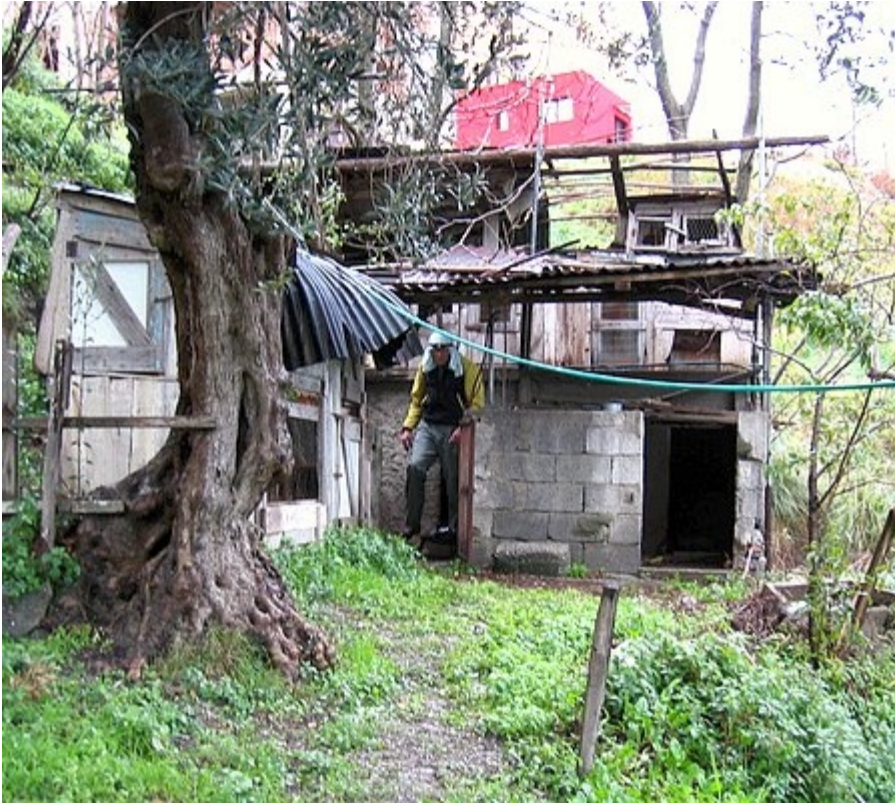
SIMO - Cetraro

In an unused pig sty down the hill from owner's house(s).
No special servicing requirements.

* Solar panel may need to be moved when trees start to get leaves.

2004:013 - serviced station. Battery dead, installed solar panel, and station seems to be operating fine.

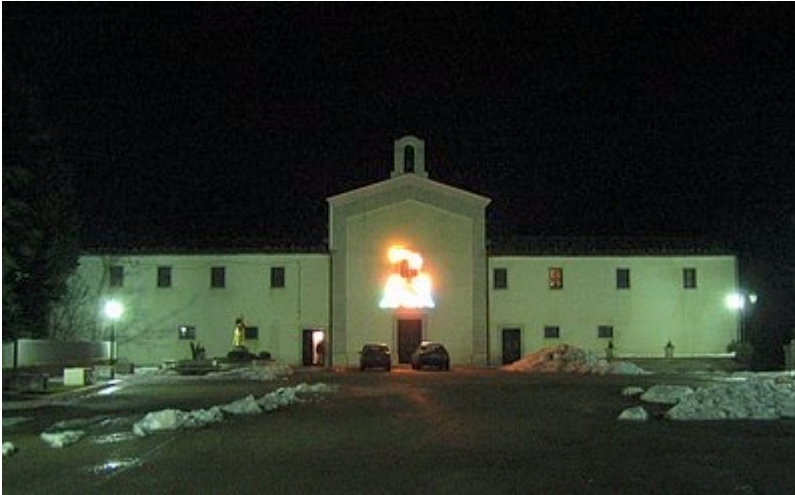
SMLC - San Marco la Catola

In storage building behind the convent down driveway on the right side of the building.

* Needs to have batteries replaced with an AC power supply.

2004:019 - Serviced station. Installed power supply and removed second battery. Sensor was off-center, and it took several tries to get acceptable centering voltages.

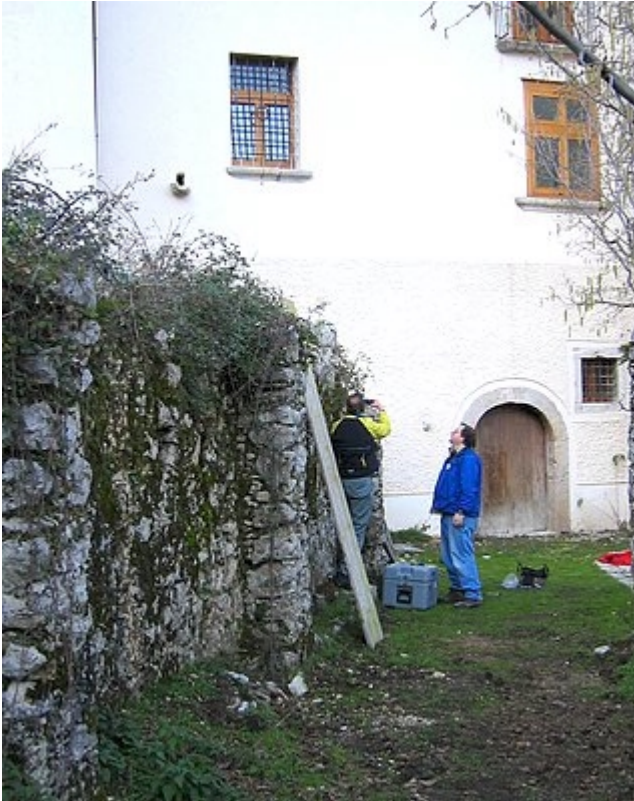
MONT - Montella

In equipment building/room with large heating unit near monastery.
Will need to call ahead to make sure caretaker will be there for
access.

* Batteries need to be replaced with an AC power supply.

2004:027 - Serviced station, retrieving 1 data flash card. Obtained
GPS serial number and replaced 2 batteries with a power supply and a
single battery. Note: electricity was initially turned off, but we
found a red lock box just outside the door with a breaker switch. Once
turned to the "ON" position, the room had electricity. When leaving
the station site, we bumped into the Michele who asked (again) for a
hard copy of a letter of permission from the boss of Montella for
participation in the experiment. After discussion, we decided that
approaching the boss may stir up more trouble, so no action was taken.

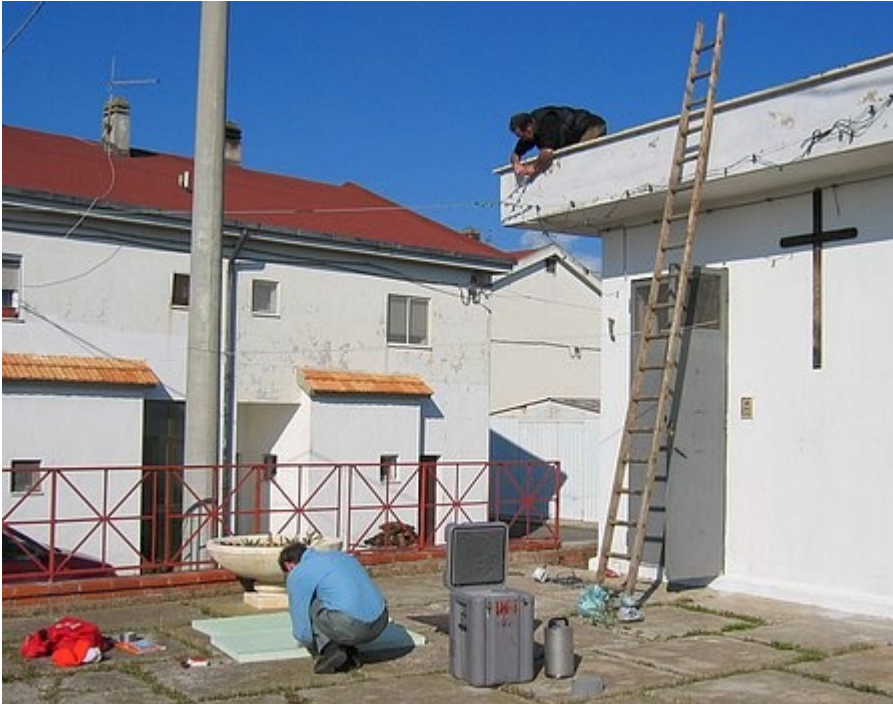
CRAC - Craco

In heater room of small church building. Door is to the left of the main entrance of the church.

2004:020 - Serviced station. Everything looked OK.

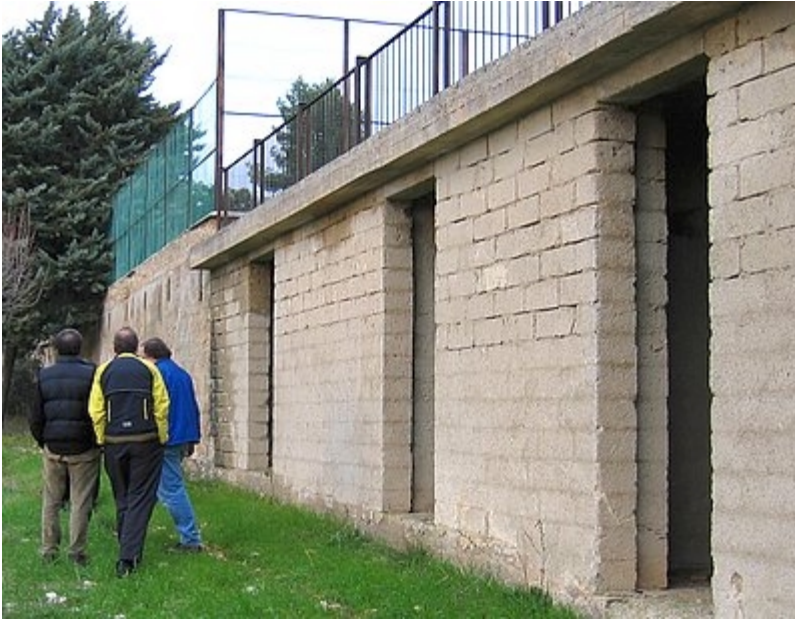
CRB - Centro Ricerche Bonomo

In room (1 of 3) under the area near the tennis courts.

Keep wiring off the ground to prevent them from being chewed on by foxes.

Ch3 centering voltage was out of range. Recentered OK.

2004:020 - Put new fencing in place.

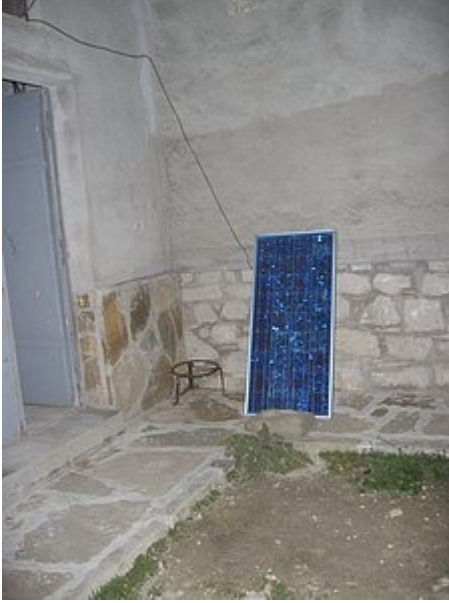
TRIC - Tricarico

GPS route file: RTTRIC.mps
In storage shed on owner's property.
No special servicing requirements.

* Need more accurate GPS positions/elevation on next visit.

2004:020 - Serviced station. Retrieved more accurate GPS location of station with hand GPS monitor. Received keys from Michele. Future visits can be made without calling, but must park outside front gate and walk around.

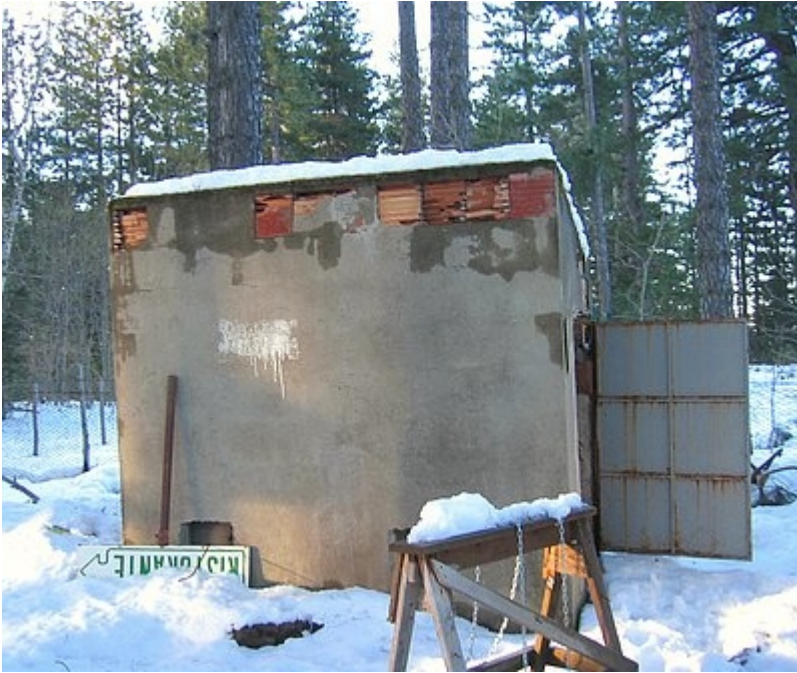
SILV - Silvana Mansio

In shed behind main hotel building. No key needed for access.

* May have left an extra sensor to DAS cable in the building on top of the propane tank. Check for it on next visit.

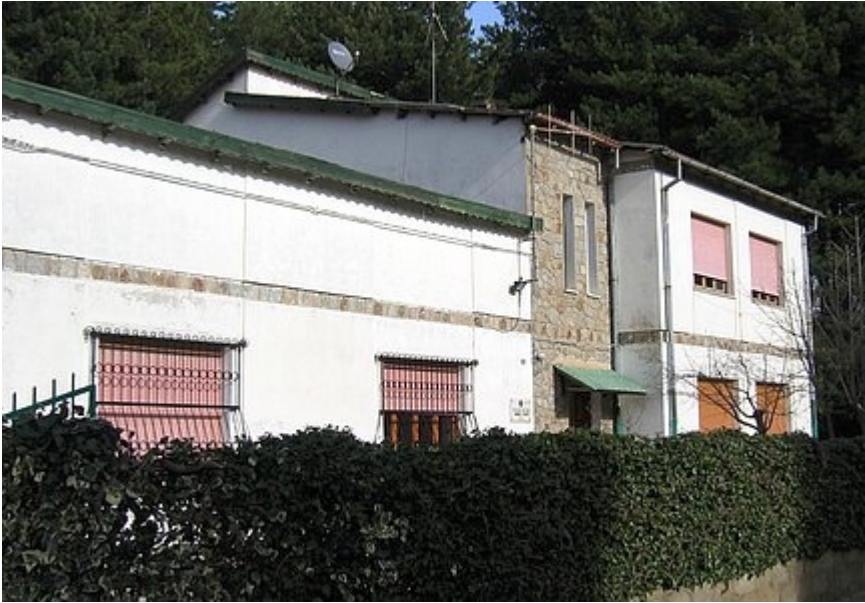
SAVE - Savelli

In basement of forestry service building.

* Check that the GPS has been locking on next visit. Had trouble getting it to lock during installation.

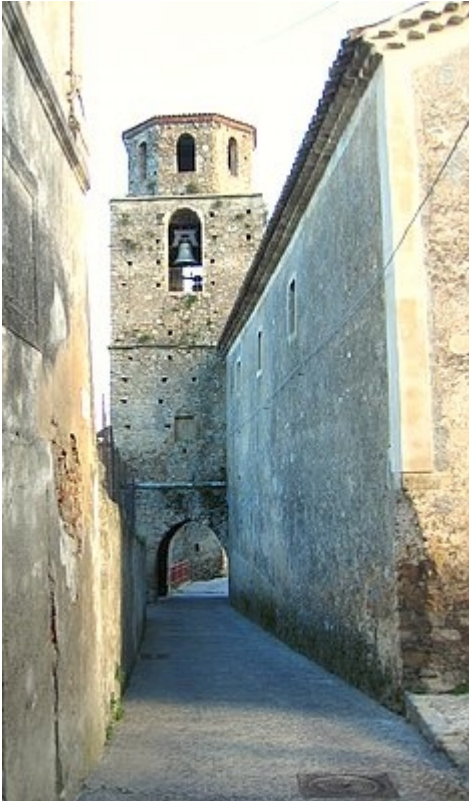
CAMP - Campana

In the crypt of the church attached to the bell tower in the picture above (side of the church is on the right side of the picture).

SPECIAL SERVICING REQUIRED: DAS has no GPS attached.

* Batteries need to be replaced by AC power supply. Power supply will need to have alligator clips to connect to the battery with until a permanent GPS cable is installed.

- Disconnect sensor from DAS
- If the batteries are not discharged too far disconnect 2nd battery from the first one (connected with automobile jumper cables)
- Carry DAS and battery outside
- Connect GPS and allow it to lock
- Stop acquisition
- Reverse procedure after servicing

* PASSCAL will be sending extra GPS cables and couplers to make a longer GPS cable.

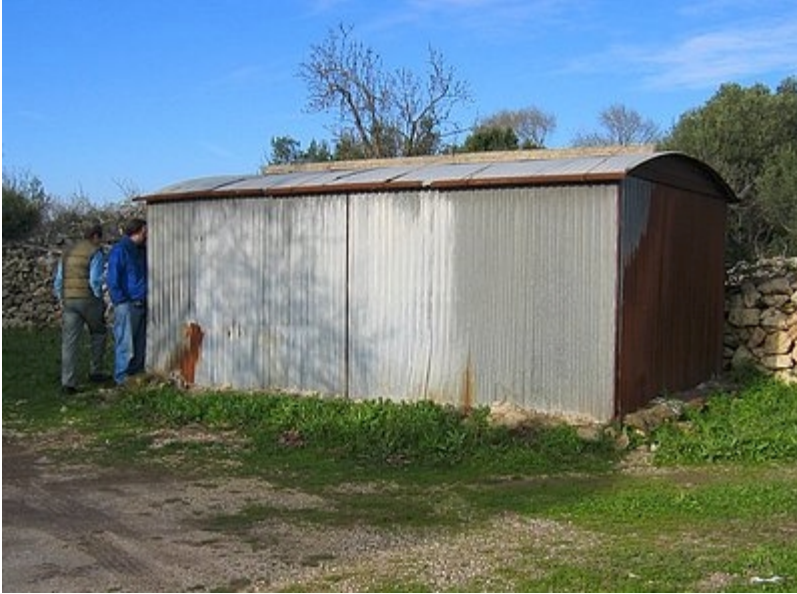
ILCA - Castellaneta

GPS route file: RTILCA.mps
In tin storage shed behind ristorante.
No special servicing requirements.

2004:020 - Serviced station. Everything looked good.

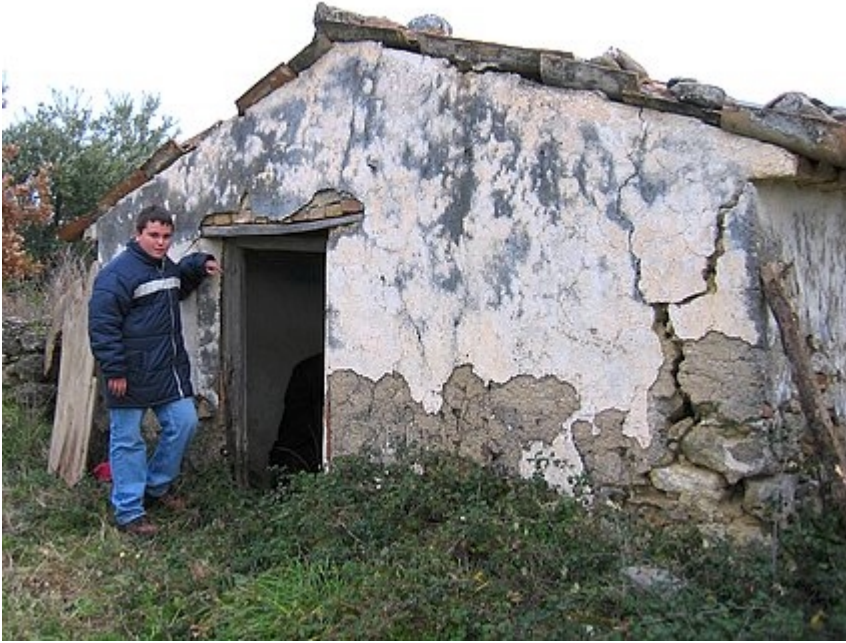
ALTO - Altomonte

GPS route file: RTALTO.mps
In rundown building in new olive grove.
No special servicing required.

* Need sensor and GPS serial numbers.

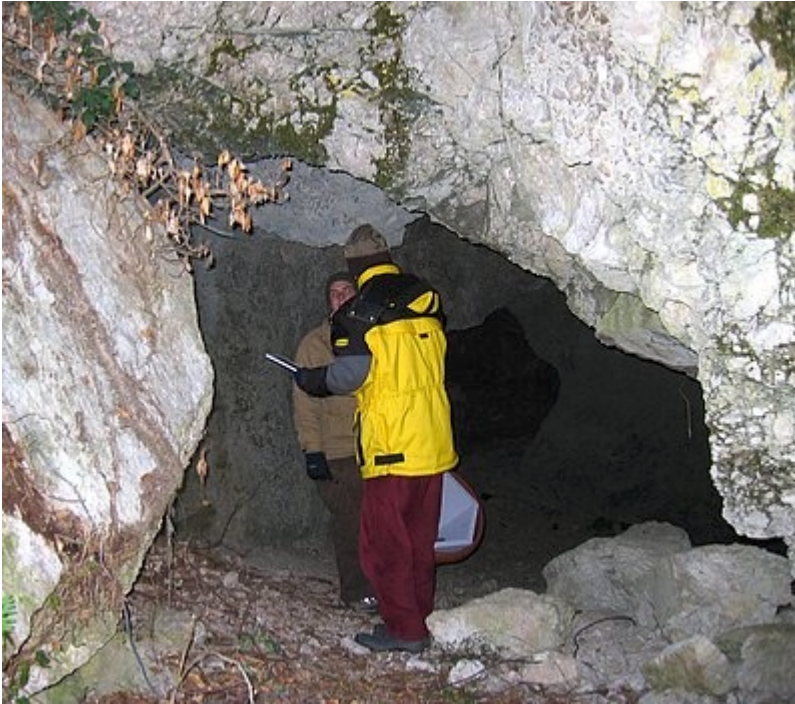
POLA - Polla

GPS route file: RTPOLA.mps
In cave on side of cliff behind the convent.
Call ahead for access.
No special servicing requirements.

2004:022 - Serviced station. Solar panel shifted to capture more direct sunlight. Battery voltage at 12.0 V. Needs monitoring to determine if a second solar panel needs to be installed. Replaced Styrofoam box with large insulated potter. Required built up topsoil to seal gap at base. Station was not level, so adjusted feet. Removed rocks precariously positioned above station.

2004:026 - Serviced station again. Retrieved 1 data flash card and checked battery voltage. Past two sunny days appear to have improved solar panel input (as well as repositioning effects), but added a second solar panel as well to ensure that the battery stays charged. Second panel required an extension of the wire, so monitoring should be done to make sure splicing was completed successfully
