Snapshot Day 10/7/08 Data (Salt Front RM 63.4)) RIVER MILE 300

Henderson Lake/Hudson River Sarah Fink, Minerva Central School District 9 -12th graders, 20 students 44°05.5135' N, 74°03.5894'W

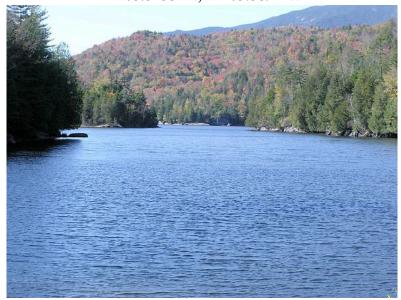
Photo taken at the Lake Henderson dam where the outflow forms the Hudson River.

This part of the lake is about 500 ft. wide.
