# LDEO LAB SAFETY GRAM

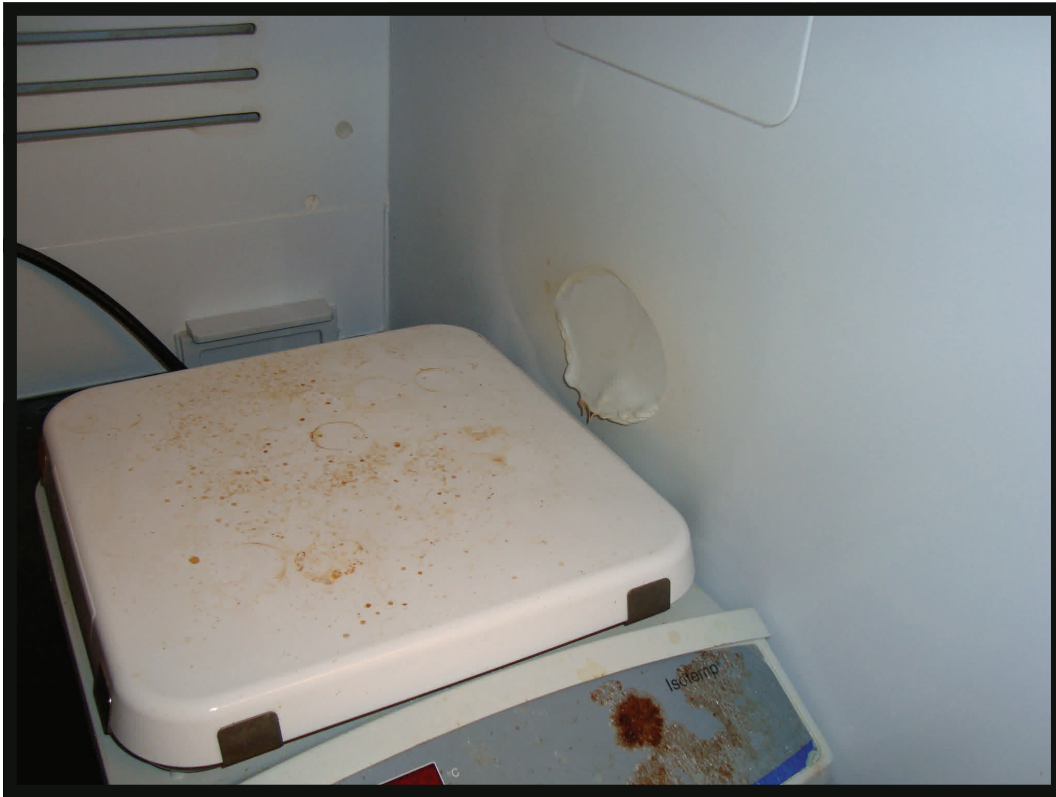
**03/06/2013**—This dangerous condition occurred as a result of a hot plate malfunction. The hot plate was reportedly turned off by the user, however, the unit did not actually cool down. Consequently, the hot plate, which was placed too close to the side of the fume hood, subsequently melted the plastic side of the hood. LDEO Safety contacted Fisher Scientific the manufacturer of the hot plate (Cat No. 11-100-100H) to inquire as to whether there had been any other such reports or recalls on this model; there were none.

Hot plates need to be operated at a safe distance from combustibles surfaces, including fume hood interiors. The typical recommended safe distance is 12 inches. This distance should be increased when there are flammable chemicals being used within the hood. Additionally, it is worth noting for all who use a hot plate that some models (such as the one mentioned above) will have a flashing “Hot Temp” lite illuminated even when the unit is turned off until the surface temperature reached 50 C.

To help prevent such damage from a malfunctioning hot plate, Standard Procedure should be: When not in use the power cord should be removed / unplugged whenever possible.
